Journal of Coastal Research SI 64	820 - 824	ICS2011 (Proceedings)	Poland	ISSN 0749-0208]
-----------------------------------	-----------	-----------------------	--------	----------------	---

Sea Cliff Retreat Mechanisms in Northeastern Brazil

O.F. Santos Jr.[†], A.C. Scudelari[†], Y.D. Costa[†] and C.M. Costa[‡]

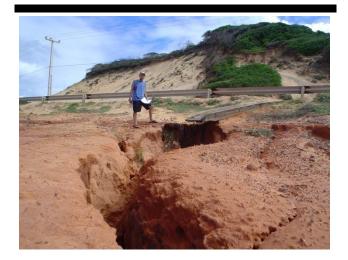
Figure 5. Erosion at the top of a sea cliff in North Sector, caused by rainwater discharge.

Ravines and gullies at the crest and at the slope surface of the sea cliffs are common in North Sector. Figure 5 shows a gully at the crest of a sea cliff, created by the discharge of a rainwater drainage device of a road located besides the cliff.

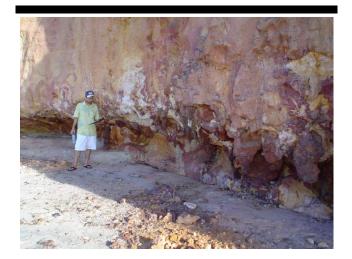
Figure 7. Erosion at the toe of the sea cliff caused by sea action in Central Section.

of the cliffs. However, a different scenario is observed at the central zone of Central Section. The comparatively narrower beaches at that zone have made possible the creation of large incisions at the toe of the cliffs due to sea action (Figure 7). The incisions at the toe of the sea cliffs usually cause block falls and slides at the upper part of the cliffs.

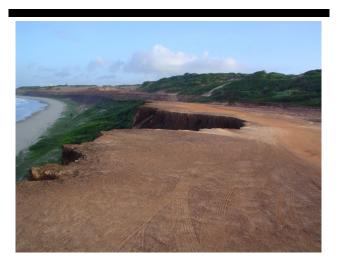
Mass movements process at South Sector consist of surficial erosion only (Figure 8). There are no records of other type of movements. The base of the sea cliffs is protected against sea action by sandstones with ferruginous cementation or sand banks along the entire length of the cliff.

Figure 8. Gully at the crest of a sea cliff at South Sector.

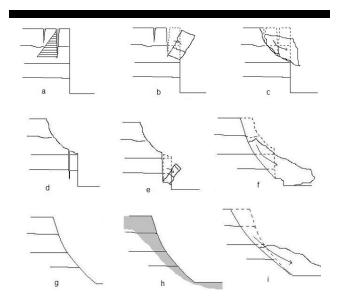
Sea cliffs at the investigated area can be grouped into three typical profiles (Figure 9). Profile type 1 includes cliffs with nearly vertical slopes (Figure 9a). Profile type 2 is characterized by cliffs with vertical slopes at the lower part and inclined slopes at the upper part (Figure 9d). The slope angle of the upper part ranges from 45° to 60° to the horizontal. Profile type 3 is composed by cliffs with slopes with inclinations varying from 40° to 50° to the horizontal (Figure 9g).

Profile 1 is very vulnerable to falls and tumbles of blocks, as well as sliding of material from the upper part of the cliff (Figures 9b and 9c). Mass movements at the sea cliffs may also be triggered by preexisting discontinuities in the soil mass, such as bedding and faults dipping towards the slope face. Sub-vertical tension cracks growing near the crest of the slope may also cause falls, tumbles and slides of material at the top of the cliffs, especially if the crack is filled with water (see Figure 9a). Water pressure pushes the block out of the cliff.

Falls and tumbles of material are common at the lower part of profile 2 due to its steep inclination. A sliding surface may also form at the upper part of the cliff. Profile 3 is comparatively more stable than the other two types, although slides and erosion at the slope surface are possible.

Topples of material from the lower part of the cliff due to preexisting discontinuities are common in profile 2 (Figure 9e). Toppling in profile 2 may be followed by massive slides (Figure 9f).

Profile 3 is characterized by surficial sliding, which is induced by the reduction in soil shear strength due to the increase of the soil degree of saturation. Figure 9h represents the saturation of the soil at the surface of the cliff. As shown in Table 1, the material of the sea cliff undergoes a severe decrease in effective cohesion after saturation, which leads to a decrease in shear strength. Soil matric suction responds for a large component of soil cohesion in the tested soil. When matric suction reduces to zero as the pores of the soil become fully saturated, soil cohesion also decreases, and part of the shear strength of the soil is lost. This condition may lead to slides of masses (Figure 9i). The reduction in soil shear strength explains why most of the slides take place during the rainy season of the year. As shown in Table 1, the reduction in soil cohesion after inundation was more pronounced with the material of the toe of the cliff.

Figure 9. Typical profiles identified at the studied area and mechanisms of failure.
