André S. Avelar⁽¹⁾, Ana L. Coelho Netto^(1,2), Willy A. Lacerda⁽²⁾,
Leonardo B. Becker⁽³⁾ and Marcos B. Mendonça⁽³⁾

Mechanisms of the recent catastrophic landslides in the mountainous range of Rio de Janeiro, Brazil

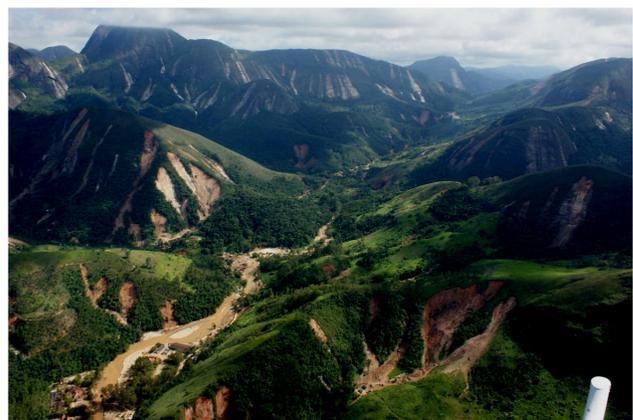
Figure 1 Aerial view of some landslides which occurred on January 12th, 2011 in the mountainous region of Rio de Janeiro State where shallow translational landslides were dominant.

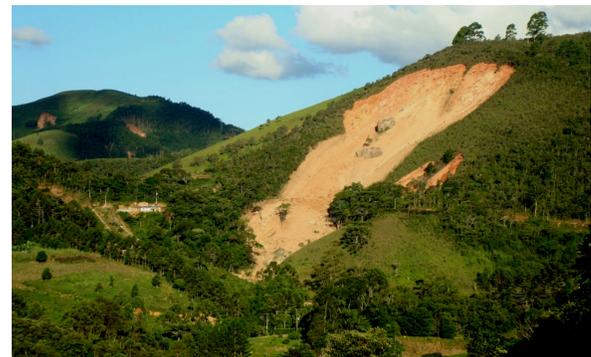
These predominant landslides present a rupture surface with a depth between 0.5 and 2.0 m, generally located within the saprolites (Fig. 3). In other cases, rupture surfaces were observed within the slope colluvium, with a depth of up to 1.0 m (Fig. 4). Also, they were observed ruptures along the soil-rock contact (Fig. 4b), with a small quantity mass of soil mobilized due to the thinness of this layer.

Figure 3 Shallow translational slide with failure surface on saprolite derived from granite.

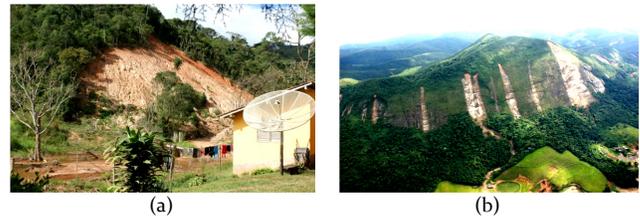
Figure 4 Landslides with failure surface in colluvium (a) and along soil-rock boundary (b).
