Ana Luiza Coelho Netto, Anderson Mululo Sato, André de Souza Avelar, Lílian Gabriela G. Vianna, Ingrid S. Araújo, David L. C. Ferreira, Pedro H. Lima, Ana Paula A. Silva & Roberta P. Silva ⁽¹⁾

January 2011: the extreme landslide disaster in Brazil

(1) Federal University of Rio de Janeiro, Nature and Mathematics Sciences Center, Institute of Geosciences, Department of Geography, GEOHECO/Laboratory of Geo-Hydroecology at Av. Athos da Silveira Ramos 274, Ilha do Fundão, Rio de Janeiro, Brazil - +55 21 94261330

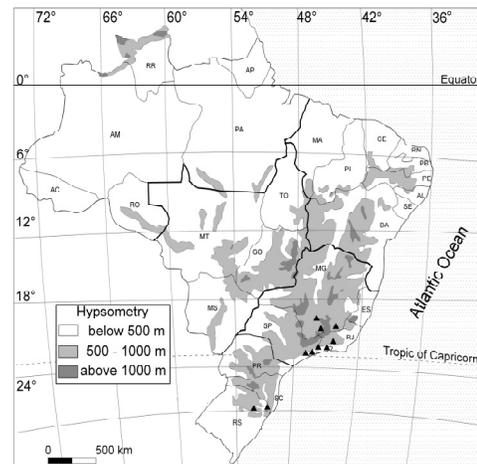
Figure 1 - Location of catastrophic landslides recorded in Brazil at Serra do Mar (Coelho Netto et al., 2010).

The disasters caused by landslides have been concentrated in the mountainous area of the southeast and south regions of Brazil, especially along the Serra do Mar, between the states of Espírito Santo and Santa Catarina (Fig. 1). Among the large magnitude disasters registered in the southeast region up to 2010, the events of 1966 in the city of Rio de Janeiro and, in 1967, in the Serra de Caraguatatuba (São Paulo state) and Serra das Araras (Rio de Janeiro state), stand out as indicated by Schuster et al. (2002). The 1966 and 1967 events in the state of Rio de Janeiro were described by Barata (1969), Costa Nunes (1969) and Jones (1973). The last author indicated that in 1967, strong storms occurred with intense electric discharges accumulating around 250 mm of rainfall in only 3 and a half hours, with an average intensity of around 100 mm.h⁻¹. Jones (1973) reports that the intense lightning and the collapse of slopes shook the region like an earthquake and tens of thousands of landslides replaced plant cover with exposed soil or rocks and drowned valley bottoms with extensive debris flows. Lacerda (1997) reinforced the possibility of an association between lightning and landslide detachment during the heavy summer storms.

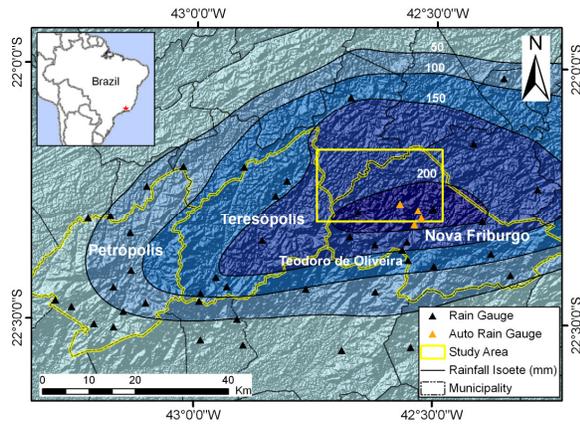
Figure 2 - Isohyets map of January 12th over the disaster region and location of the rain gauge stations (N=47); the rectangle indicates the detailed study area.

Rainfall records were obtained from 47 rainfall stations, of which four were automatic (Fig. 2). The spatial distribution of January 12th data were analyzed and interpolated by using the Kriging method. This interpolation was undertaken using the weighting parameters determined by the analysis of directional semivariograms expressing an anisotropy in the accumulated rainfall values. The isohyets map on January 12th in Fig. 2 shows that the rainiest cell (> 200 mm) occurred in the center of Nova Friburgo.

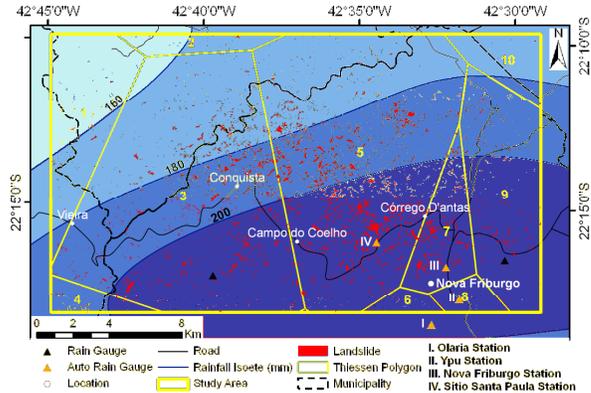
Figure 3 - Map of landslide scars within the rainfall isohyets and Thiessen polygons of January 12: 1- Córrego Sujo, 2-Sumidouro, 3-Fazenda Mendes, 4-Friburgo/INMET, 5-Sítio Santa Paula, 6-Olaria, 7- Nova Friburgo, 8-Ypu, 9-Vargem Grande, 10-Bom Jardim.

The landslide scars were mapped over the Geoeye image made on January 19th, 2011 available on Google Earth 6.0 program, using the “add polygons” tool. The polygons generated were saved in .kml format and imported into ArcGIS 9.3 with the X Tools Pro 7.1 extension. In Fig. 3 a spatial distribution of the landslide scars can be observed. It was noted that the main landslides occurred in the rainiest area. As the rainfall decreases, a progressive increase in the frequency of landslide scars of smaller sizes increases. Of the total number of landslides (N= 3622), it was verified that the frequency of landslide occurrence in isohyets varied in direct relationship with the rainfall size: only 2.7%

between 140 and 160 mm; 22.7% between 160 and 180 mm; 34.6% between 180 and 200 mm and 40.0% in the area of rainfall >200 mm. The locations with the largest number of landslides were associated with Fazenda Mendes polygon (#3, N = 1174) and Sítio Santa Paula (#5, N = 1558), as presented in Tab. 1.

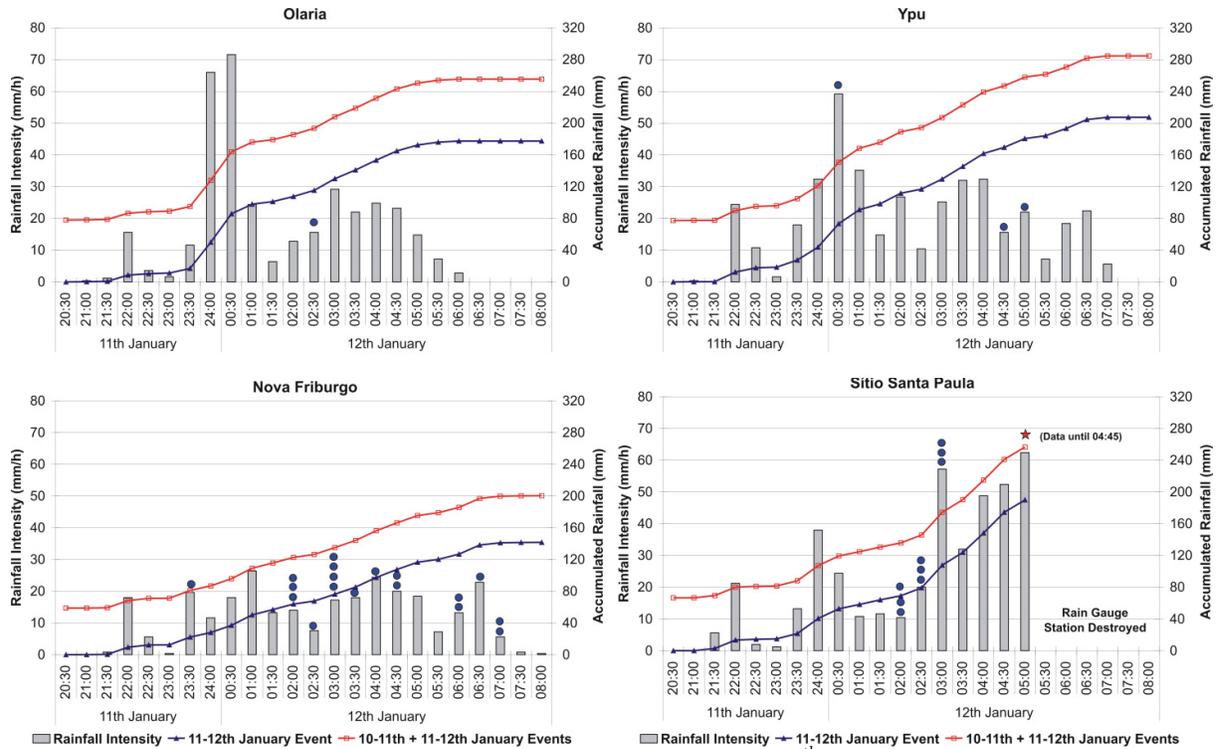
Figure 4 – Histogram of rainfall intensity distribution ($\text{mm}\cdot\text{h}^{-1}$) during the January 11-12th event and accumulated rainfall curves during the same event as well as those accumulated on January 10-11th and 11-12th 2011 events. Blue dots indicate landslide occurrences.

The rainfall data registered in these four stations between January 11 and 12 were analyzed for intensity distribution (mm.h⁻¹) at half hour intervals (Fig. 4). This figure shows the rainfall intensity histograms, along with the two accumulated rainfall curves: one refers to the critical event on January 11-12 and the other accumulates the previous event. During the continuous rainfall period from January 11-12th, a lower rainfall value was registered at the Nova Friburgo station (~140 mm); the other stations registered ~180 mm (Olaria); ~205 mm (Ypu) and, until it was destroyed at 5 am, the Sítio Santa Paula

station registered ~190 mm. The rainfall intensity varied considerably in time and also between the four stations. The only landslide nearby the Olaria station occurred around two hours after the peak intensity (~15 mm.h⁻¹) and accumulated since the beginning of the event close to 115 mm along with the previous day totaling ~190 mm. Around the Ypu station, the first analyzed landslide occurred when the accumulated rainfall was ~70 mm and reached the maximum of ~60 mm.h⁻¹ and, after an accumulated rainfall around ~170 mm, two more landslides occurred. In the area around the Sítio Santa Paula station, three landslides occurred: under rainfall intensity of 10 mm.h⁻¹ and accumulated rainfall of 70 mm, with 135 mm accumulated the previous day; three others occurred under a rainfall intensity equal to 20 mm.h⁻¹, with 80 mm of accumulated rainfall and 145 mm accumulated the previous day and three others when the intensity reached the peak value with ~55 mm.h⁻¹ and accumulated rainfall of 107 mm that, accumulated the previous day reached 174 mm total. At the Nova Friburgo station, the rainfall was well distributed and the intensity prevailed around 20 mm.h⁻¹. The majority of the landslides occurred under rainfall intensity below 20 mm.h⁻¹. Even at the end of the rainfall, with a low intensity (~ 5 mm.h⁻¹), two more landslides occurred.

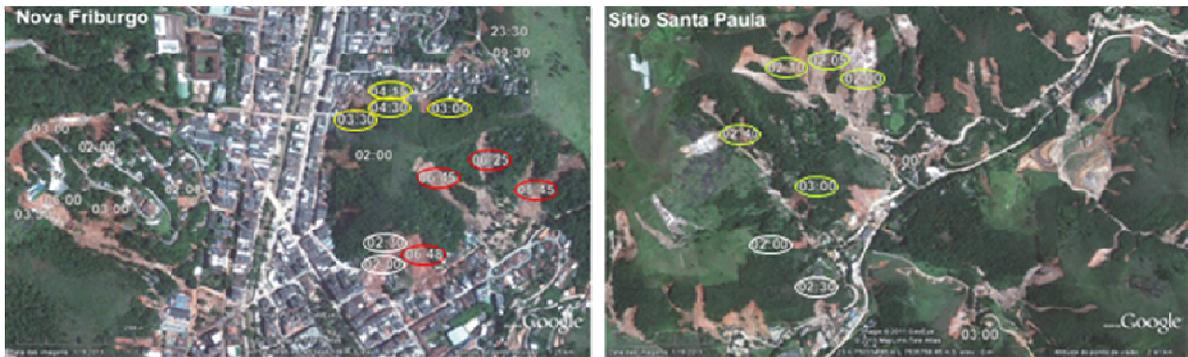
Figure 5 – Landslides detonation time presented in fragments of Geoeye images from Google Earth within a 1 Km radius around Nova Friburgo station, in the city center of Nova Friburgo, and around Sitio Santa Paula station, in the rural area.

In Fig. 5 the landslide triggering time reported by local residents within a 1 Km radius of the Nova Friburgo and Sítio Santa Paula stations were plotted. We note the spatial and temporal variation of hours for the detonation of landslides between the two areas and within each. The grouping of cases with little difference in time, indicate certain sequencing in triggering landslides at both areas.

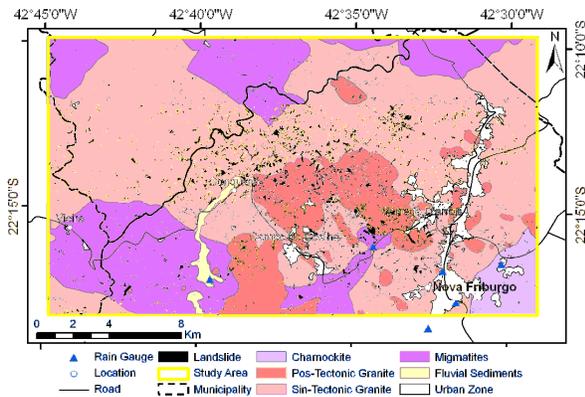
Figure 6- Geological map (1:50,000, DRM-RJ) and 2011 landslide scar map.

The studied area is dominated by post and sin-tectonic granite (63.0%) and migmatites (14.4%) as evident in Fig. 6 and Tab. 3. The table shows the largest density of landslides over post-tectonic granite although its area of occurrence is relatively more restricted in relation to sin-tectonic granites. The urban zone is part of the granite area and also presented a high density of landslides ($7.6\cdot\text{km}^{-2}$). The high density of fractures that favor the formation of *in situ* blocks, provided the incorporation of a high load of blocks to landslide material. Older block rich colluvial deposits were also exhumed and incorporated into the mass of debris in valley bottoms. Materials mobilized on the slopes fed extensive avalanches rich in blocks and organic debris along the

river valley bottoms forming torrents of great magnitude, in turn overflowing the canals and modifying the canal and the floodplain morphology. In these locations, all forms of human occupation (homes, agricultural areas, roads, among others) were destroyed or buried.

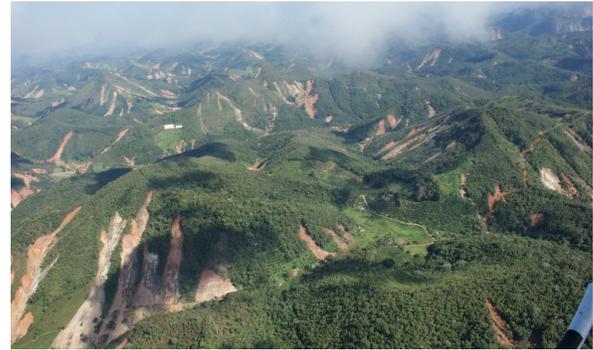
Figure 7 – Panoramic view of the January 11-12th landslides in the rural areas of the Nova Friburgo municipality.

A digital elevation model (DEM) with 20 m resolution was generated from the 1:50,000 scale topographic maps from IBGE (Instituto Brasileiro de Geografia e Estatística). Then, the slope map and Topographic Position Index (TPI), as proposed by Jenness (2006), were obtained. Crossing the slope maps with the map of the classification of slope position, it was verified that the largest part of the landslides occurred on the ridge and upper slope positions (1982 cases or 55%); the rest occupied the middle and lower slopes, as illustrated

in Fig. 7. Taking the total landslide area into account in these three positions (ridge+upper slopes=3.5 km²; middle=6.5 km² and lower=5.7 km²), it was shown that smaller landslides dominated at the highest parts of the slopes.
